Aprehend® Case Study – Apartment Complex in Tennessee

HTP Termite and Pest Control, Huntingdon, TN
Clint Collins, Inspection supervisor

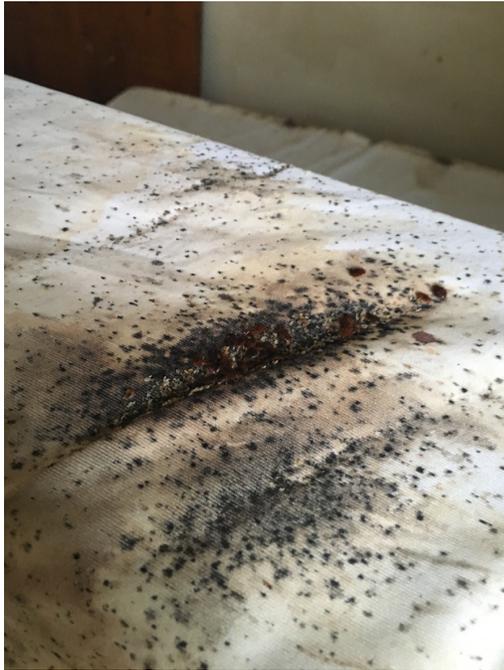
Upon inspection, HTP identified 16 apartments with visible signs of bed bug infestation. Two units were identified as the likely major sources of the infestation. These units were adjacent to each other, and both were in a similar state of disarray. The beds in these apartments had been fitted with box spring and mattress encasements, but at the time of inspection, these were heavily soiled with bed bug feces.

Figure 1: A heavily soiled encasement from one of the suspected source units

1. Mattresses and box springs were dusted with Cimexa™ and sealed inside encasements (CleanBrands®). Apartments where no visible bed bugs were present did not receive encasements.

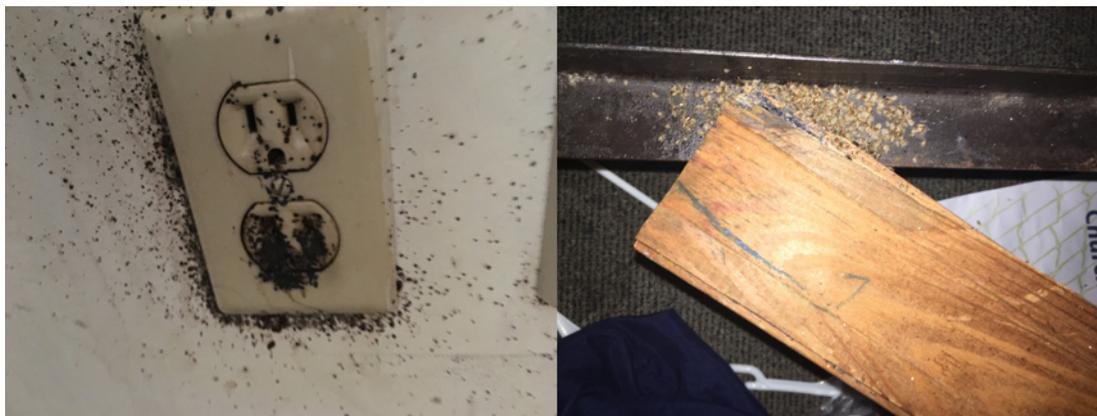
Figure 2: Other signs of the infestation; wall socket & bed frame

7. Aprehend® barriers were also applied to the walls around electrical outlets and phone jacks etc.

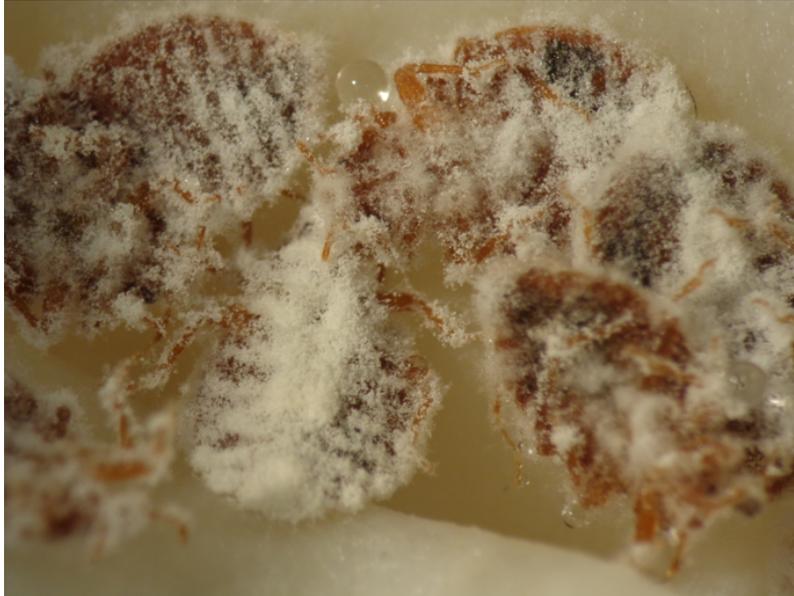
- 1) The paper towel should be wetted under the tap and squeezed to remove excess water.
- 2) Place the moist paper towel in a zip-lock bag and place the live or dead bed bug on the paper towel.
- 3) Zip up the bag and leave it at room temperature for three or four days.
- 4) Inspect the bed bug. If it was sick or dead from the fungal disease in Aprehend[®], the bed bug will have become white and fuzzy with the fungus (*Figure 3*)

(The live bed bug collected during the 30-day follow-up died in the bag and produced the fuzzy bloom confirming that it was sick and would have died from exposure to Aprehend[®] within a day, even if it had been left in the apartment.)

Figure 3: Bed Bugs with external sporulation after the “zip-lock” test
